# Inspection Report

**Property Address:**  
123 Anywhere st  
Irmo sc

<b>Date:</b> 8/29/2009	<b>Time:</b> 05:13 PM	<b>Report ID:</b> 1998
<b>Property:</b> 123 Anywhere st Irmo sc	<b>Customer:</b> Mr. Jane Doe	<b>Real Estate Professional:</b>

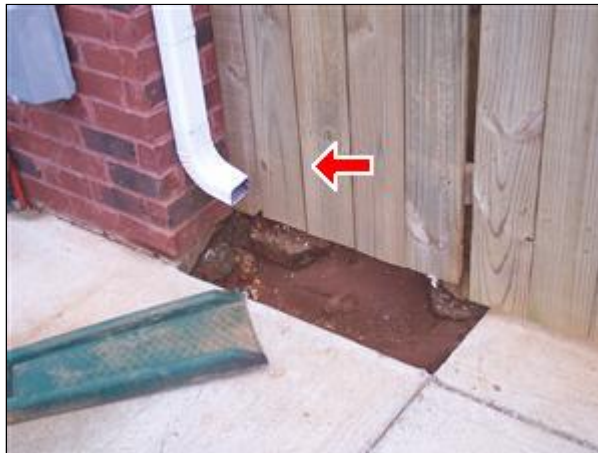
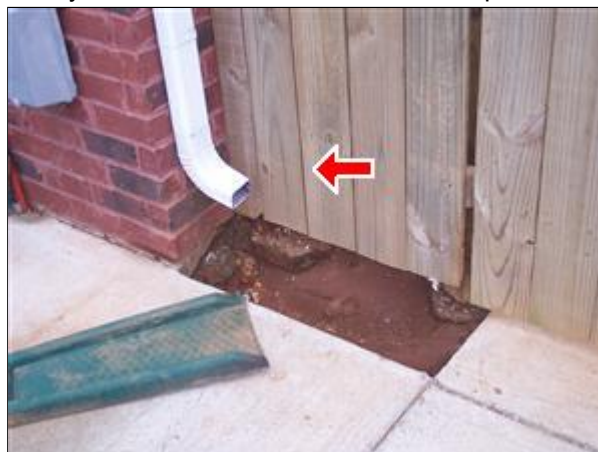
2.4 Picture 1

2.4 Rear gutter need to be deflected away from the house to avoid moisture penetration into the crawl space.

Rear gutter need to be deflected away from the house to avoid moisture penetration into the crawl space.

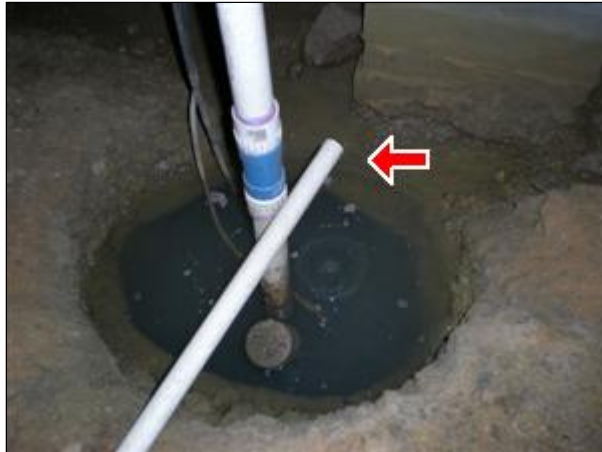
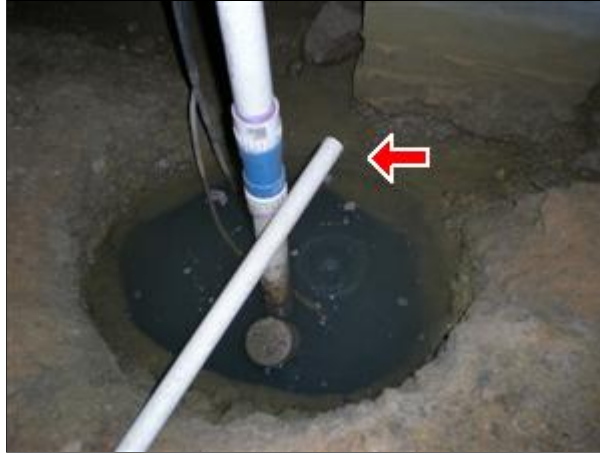
5.0 Picture 1

5.0 Condensation line is draining into the sump pump which is not operational. This pipe needs to be routed outside of the home to avoid additional moisture penetration.

Condensation line is draining into the sump pump which is not operational. This pipe needs to be routed outside of the home to avoid additional moisture penetration.

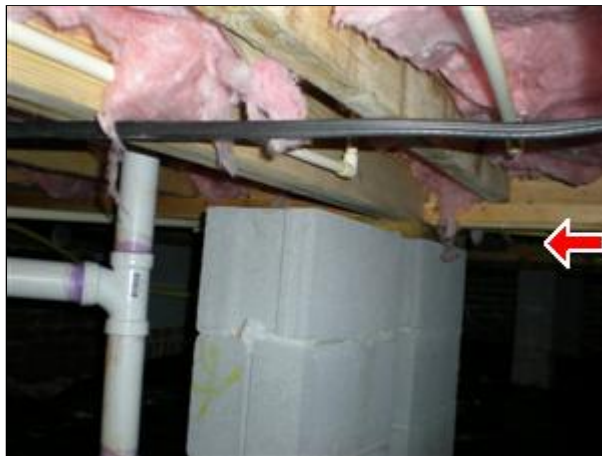
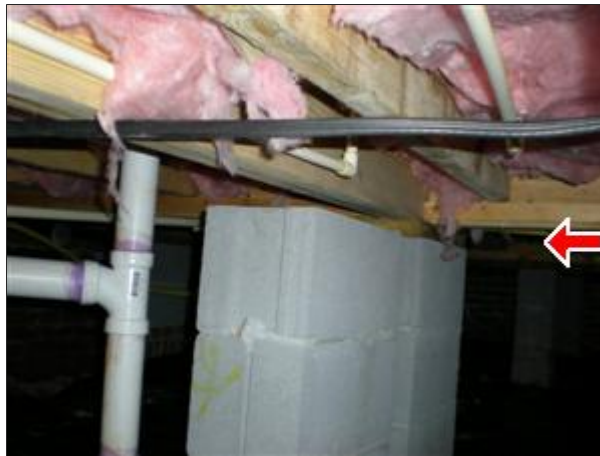
5.2 Picture 1

5.2 One support column is not in contact with the structure. Recommend licensed contractor investigate and repair/replace.

One support column is not in contact with the structure. Recommend licensed contractor investigate and repair/replace.

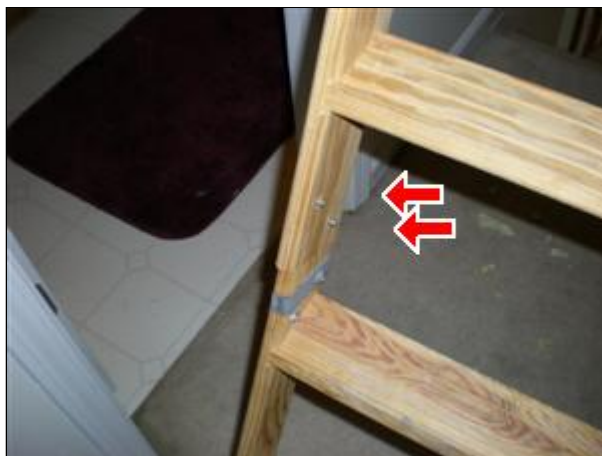
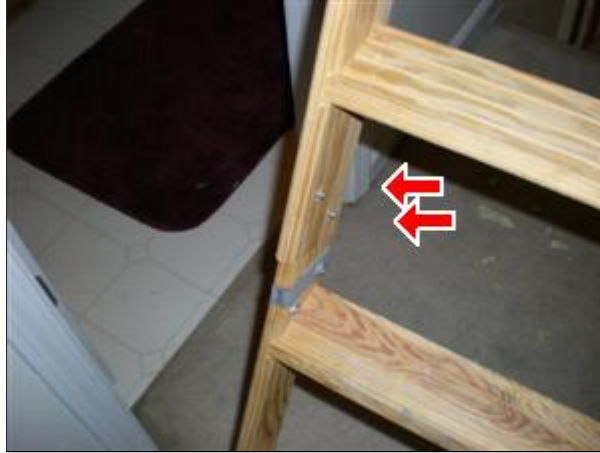
5.5 Picture 1

5.5 (1) Pull down stairs missing bolts and nuts. Do not use until fixed.

(1) Pull down stairs missing bolts and nuts. Do not use until fixed.

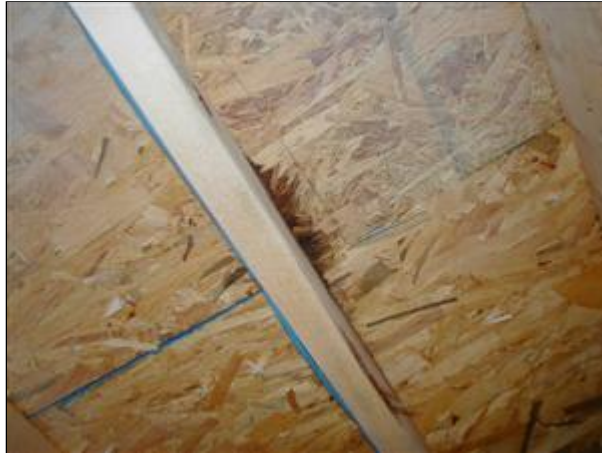
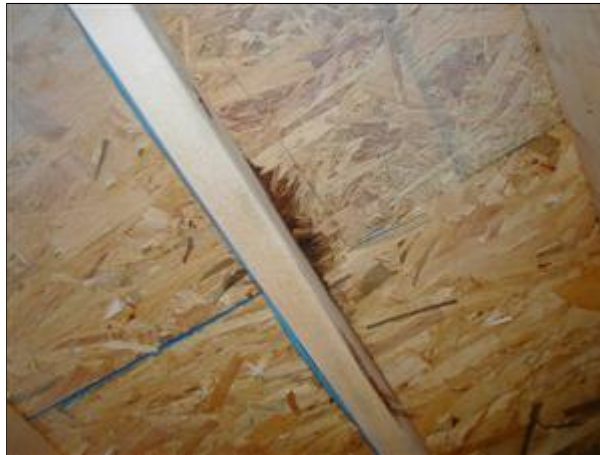
5.5 Picture 2

(2) Evidence of moisture penetration over 3rd bedroom upstairs. This leak is active. Recommend roofing company and/or general contractor repair.

(2) Evidence of moisture penetration over 3rd bedroom upstairs. This leak is active. Recommend roofing company and/or general contractor repair.

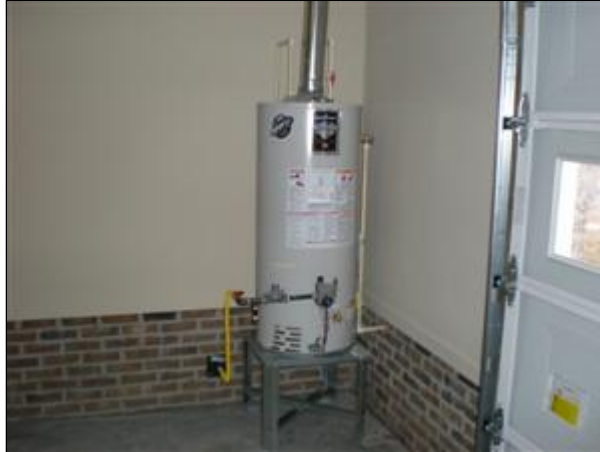
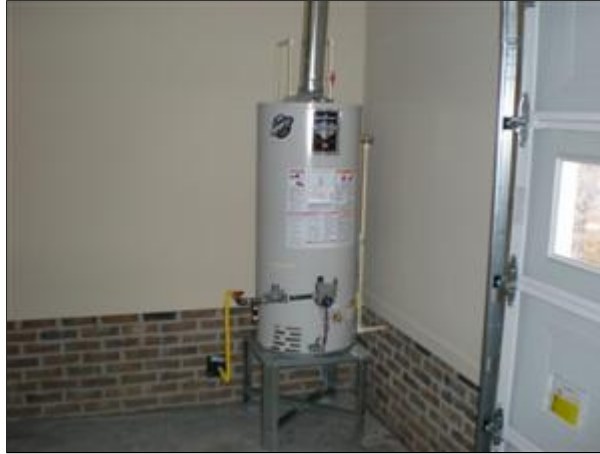
6.2 Picture 1

**6.2** Hot water heater in the garage is not secured to the structure. Recommend placing a strap around the heater and fastening to wall to avoid falling over and possible severing the gas line.

Hot water heater in the garage is not secured to the structure. Recommend placing a strap around the heater and fastening to wall to avoid falling over and possible severing the gas line.

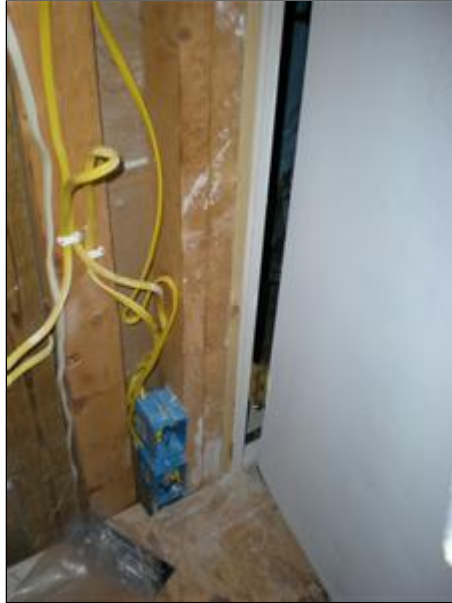
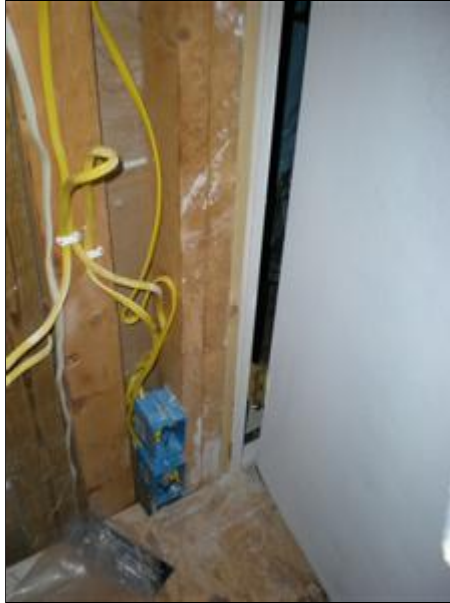
7.3 Picture 1

7.3 (1) Exposed wiring in attic. Recommend box covers to avoid contact.

(1) Exposed wiring in attic. Recommend box covers to avoid contact.

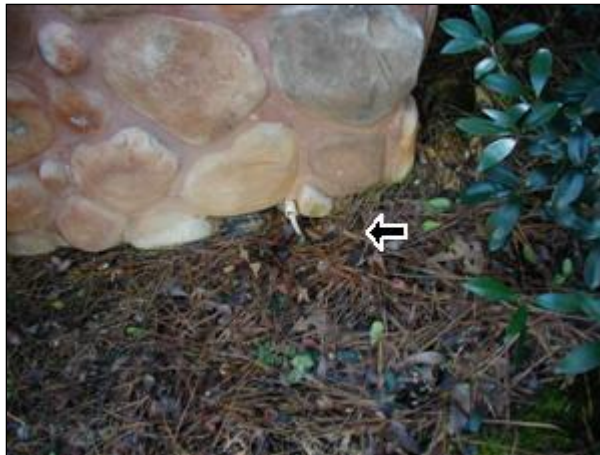
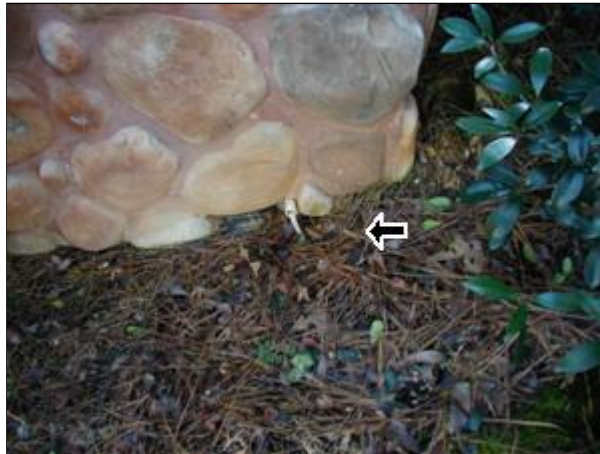
7.3 Picture 2

(2) Outside exposed wire needs to be replaced with proper outside wire and/or conduit.

(2) Outside exposed wire needs to be replaced with proper outside wire and/or conduit.

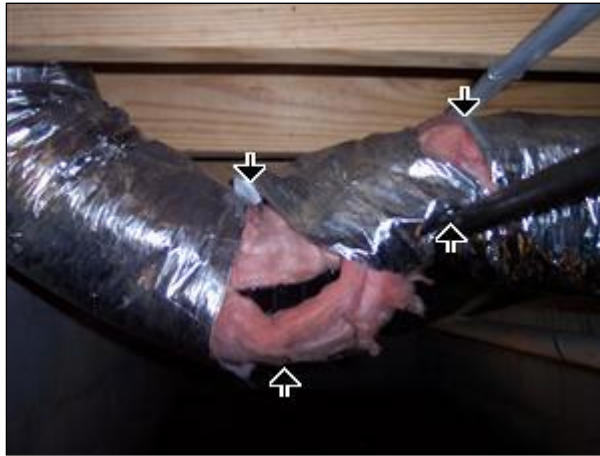
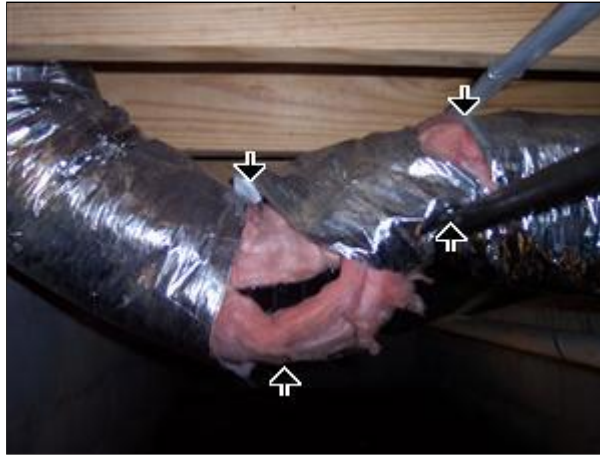
8.3 Picture 1

8.3 (1) Supply duct pipe appears crimped and is damaged at floor register in crawlspace left of crawl door.

(1) Supply duct pipe appears crimped and is damaged at floor register in crawlspace left of crawl door.

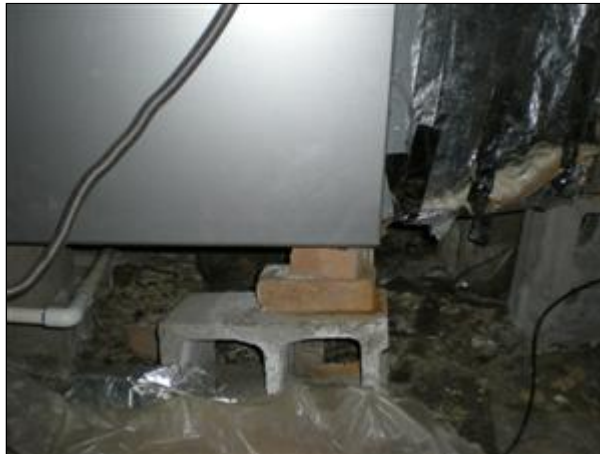
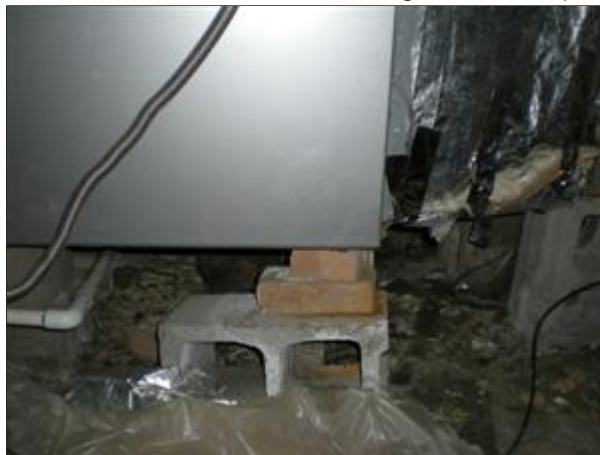
8.3 Picture 2

(2) Air handler need to be stabilized. Recommend licensed heating and air company repair.

(2) Air handler need to be stabilized. Recommend licensed heating and air company repair.
